**THE RED HOUSE
HOUGHTON REGIS
BEDFORDSHIRE**

HISTORIC BUILDING ASSESSMENT

Project: CO2821

Document: 2016/147

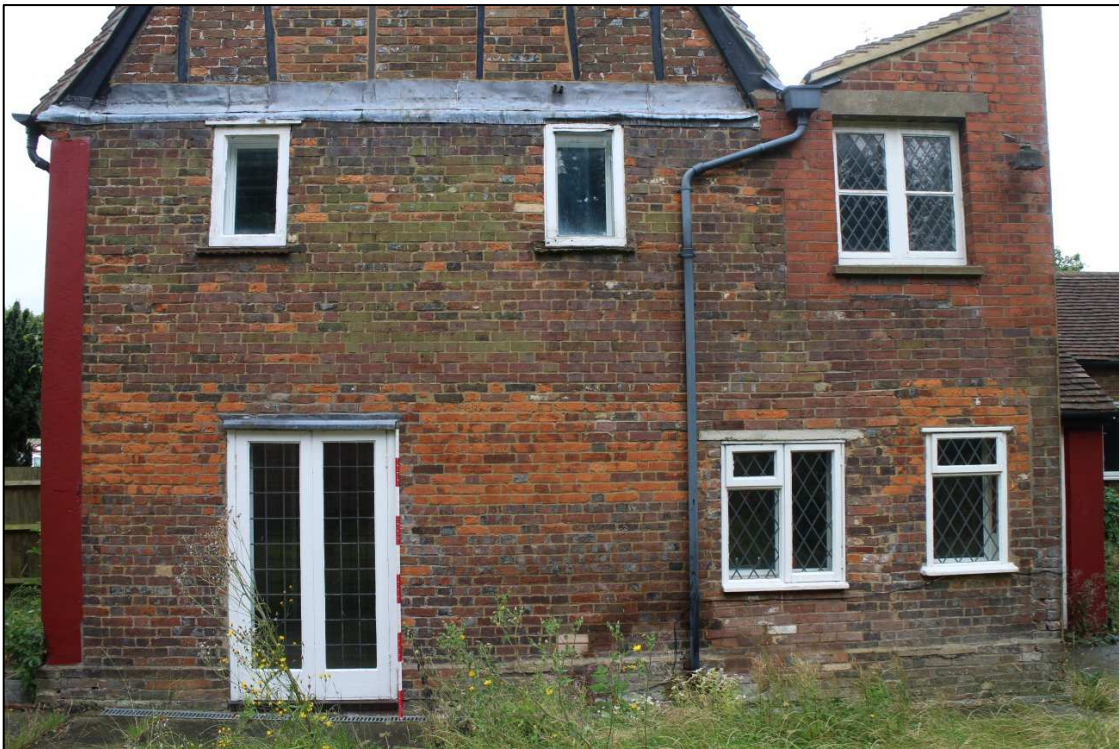
Image 3: Exterior, north-west elevation

This wall is in brick in Flemish bond (Image 3). It is on a low brick plinth. The brickwork is mainly in handmade red and purplish-red bricks with some dark over-fired examples and burnt headers. At the left side is the cement strip noted in the front elevation.

Note change in brickwork at top right where a first floor has been added to a rear outshot

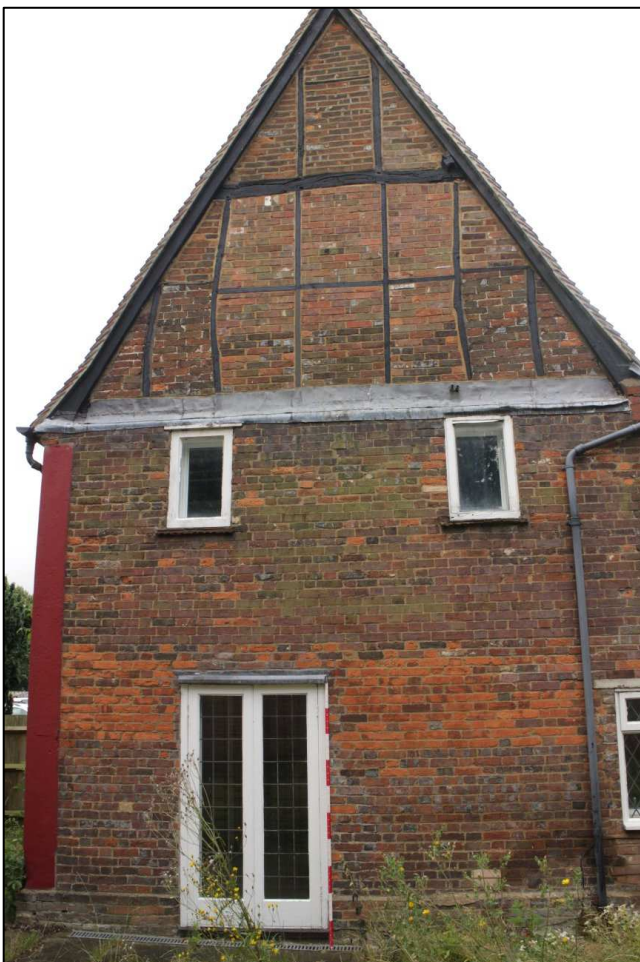
Image 4:
Exterior, north-west
elevation

The brickwork appears to have been repointed and the central six panels in the gable have been rebuilt in reused brick and the studs replaced with new timber.

Showing details of gable end
with collar beam, clasped
purlin and rebuilt brick noggin
in the central panels below the
collar beam

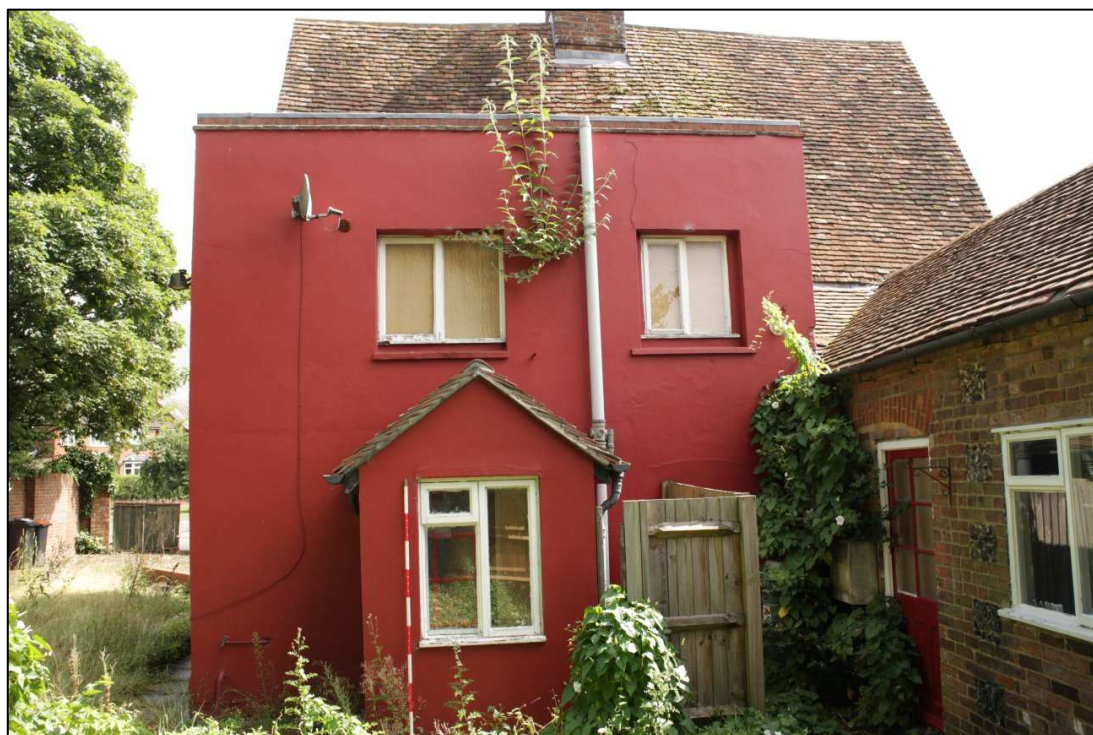
Image 5: Exterior, rear elevation

Shows rendered rear wall of rear extension /outshot with modern windows and arch of blocked opening just visible through render at lower right (behind wooden fence)

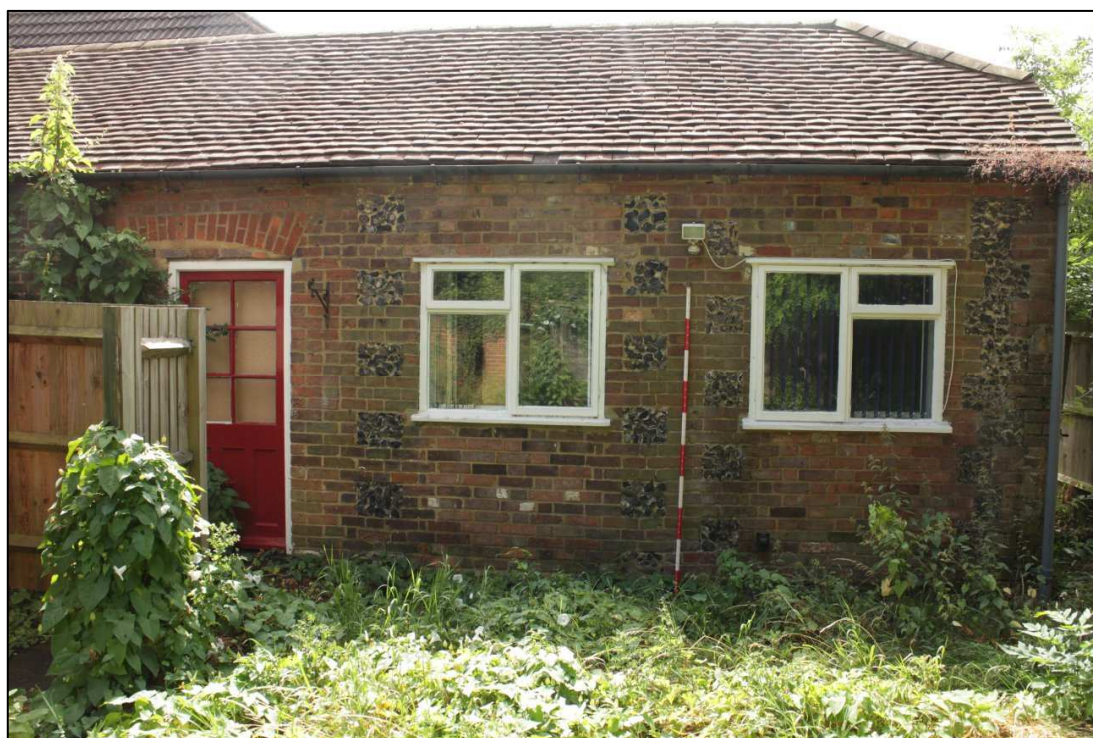
Image 6: Exterior, north-west elevation of south range

Shows modern door inserted into partially blocked opening with brick arch at left and modern windows in two partially blocked openings at right

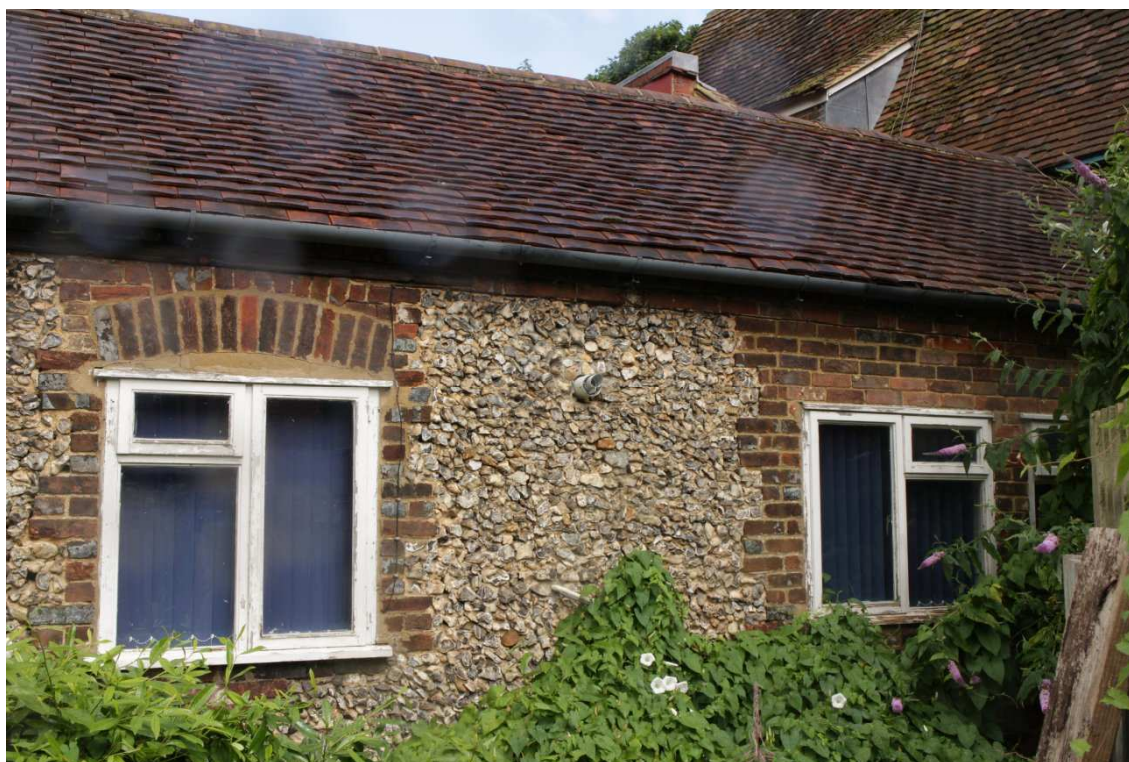
Image 8: Exterior, south-east elevation of south range

Shows modern windows inserted into earlier openings with brick dressings

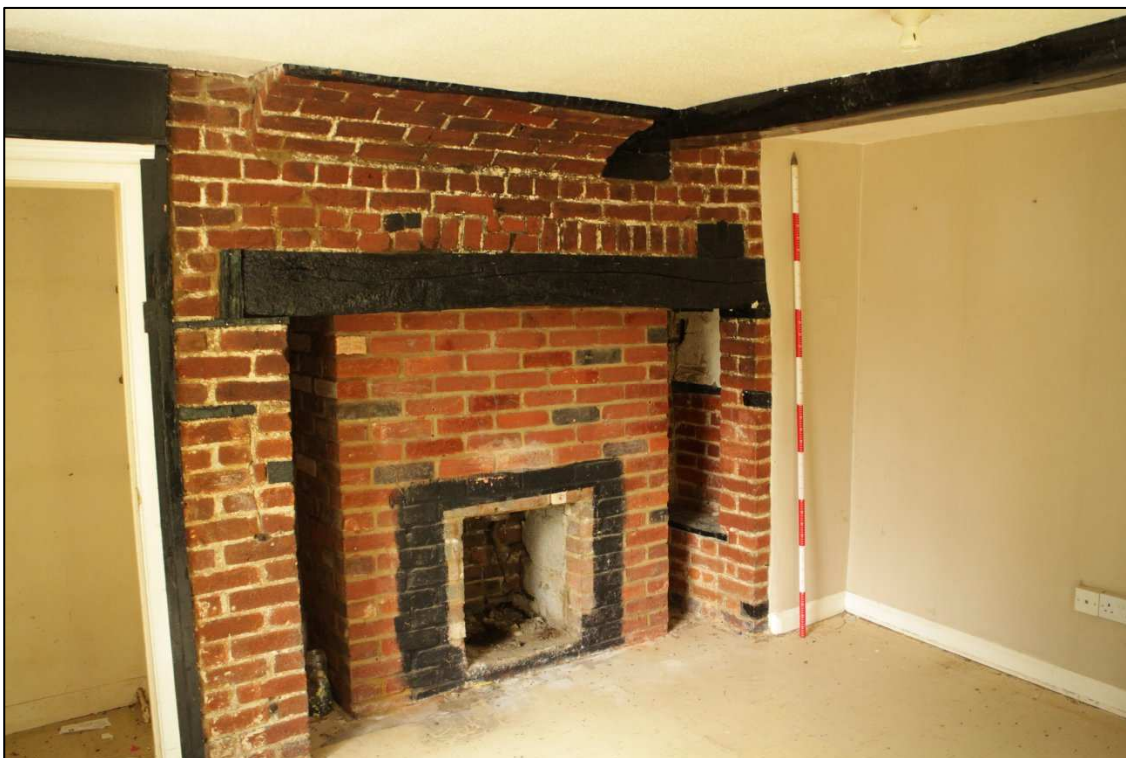
Image 9: Interior, Room G1

Fireplace with inserted modern fireplace, trimmer arch over fireplace and offset spine beam in ceiling

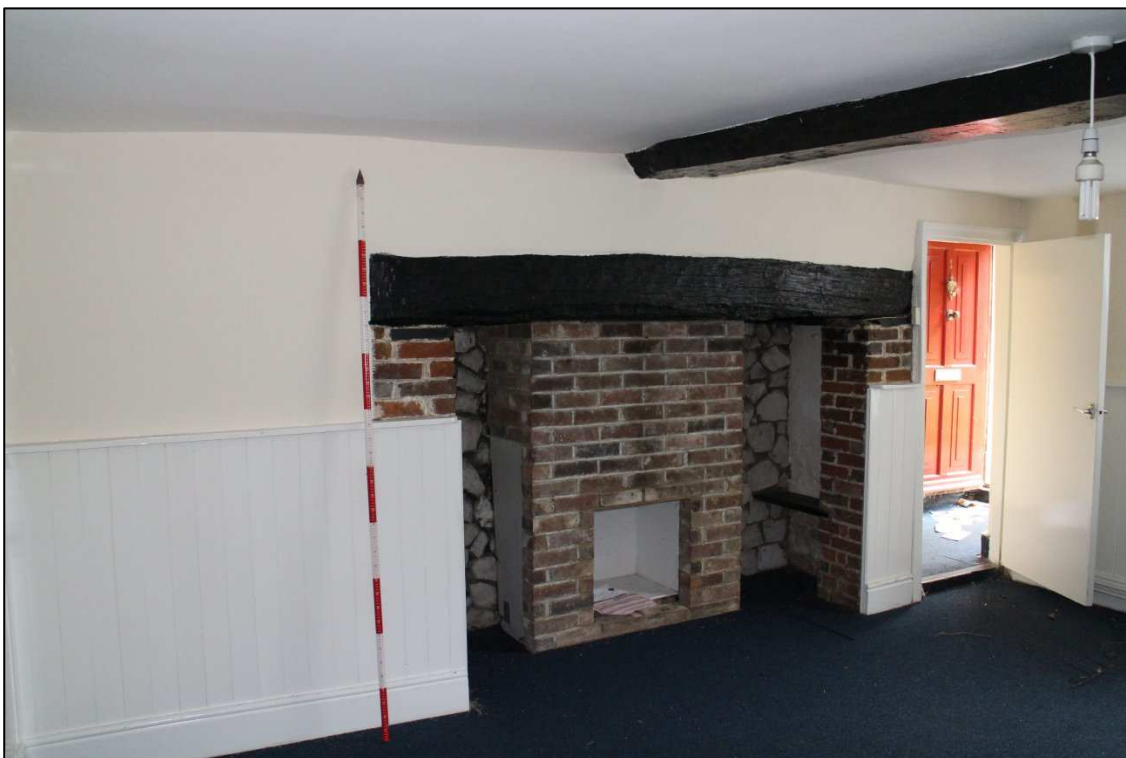
Image 10: Interior, Room G2

Fireplace with irregular rubble in back of hearth and modern inserted fireplace

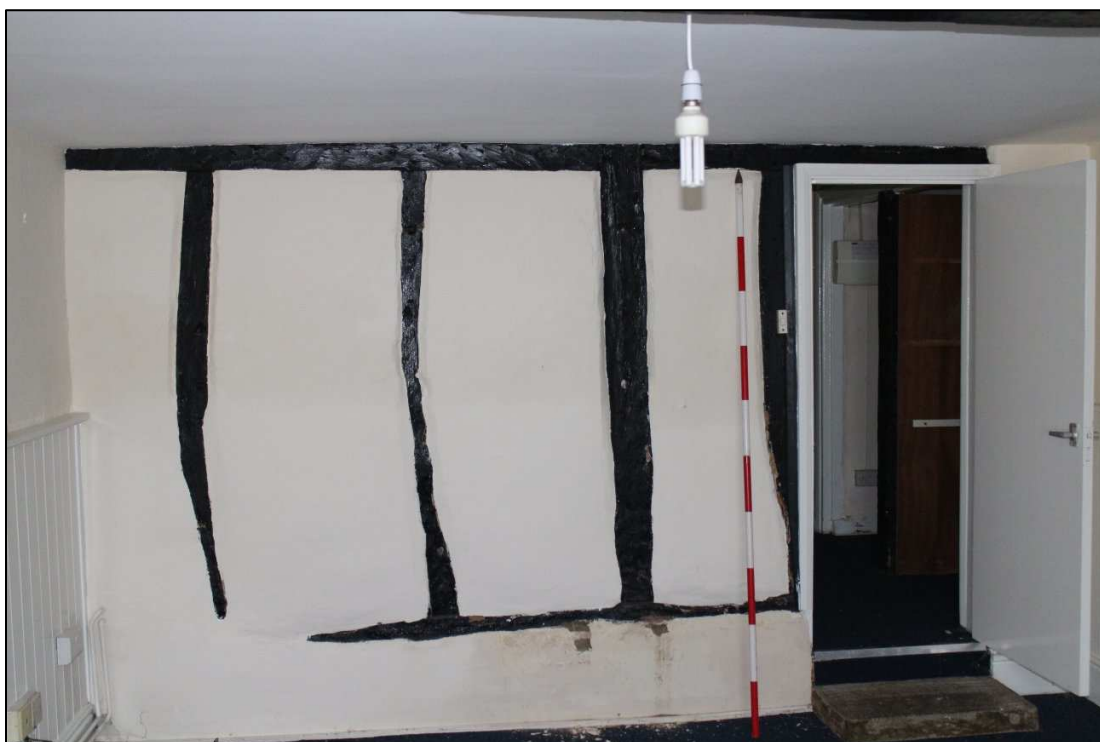
Image 11: Interior, Room G2

Timber frame in western side of room comprising post and studs on low sill wall

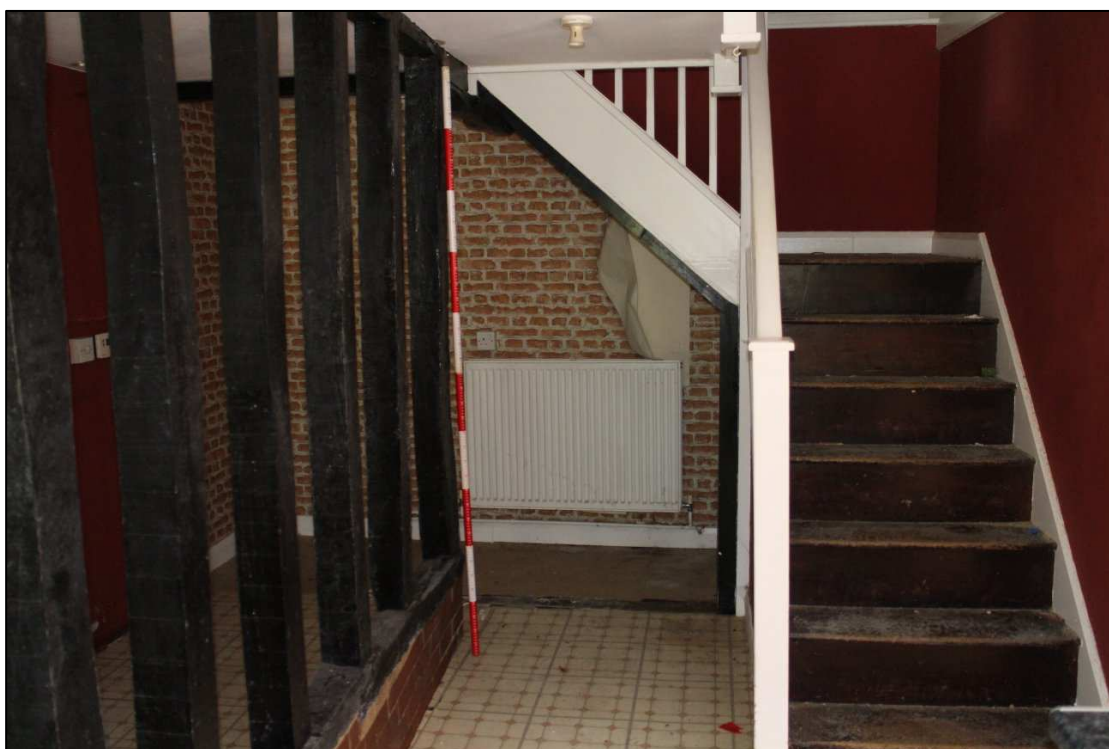
Image 12: Interior, Room G3

Southern end of room with 20th-century staircase and open partition on line of former rear wall of primary range visible at left

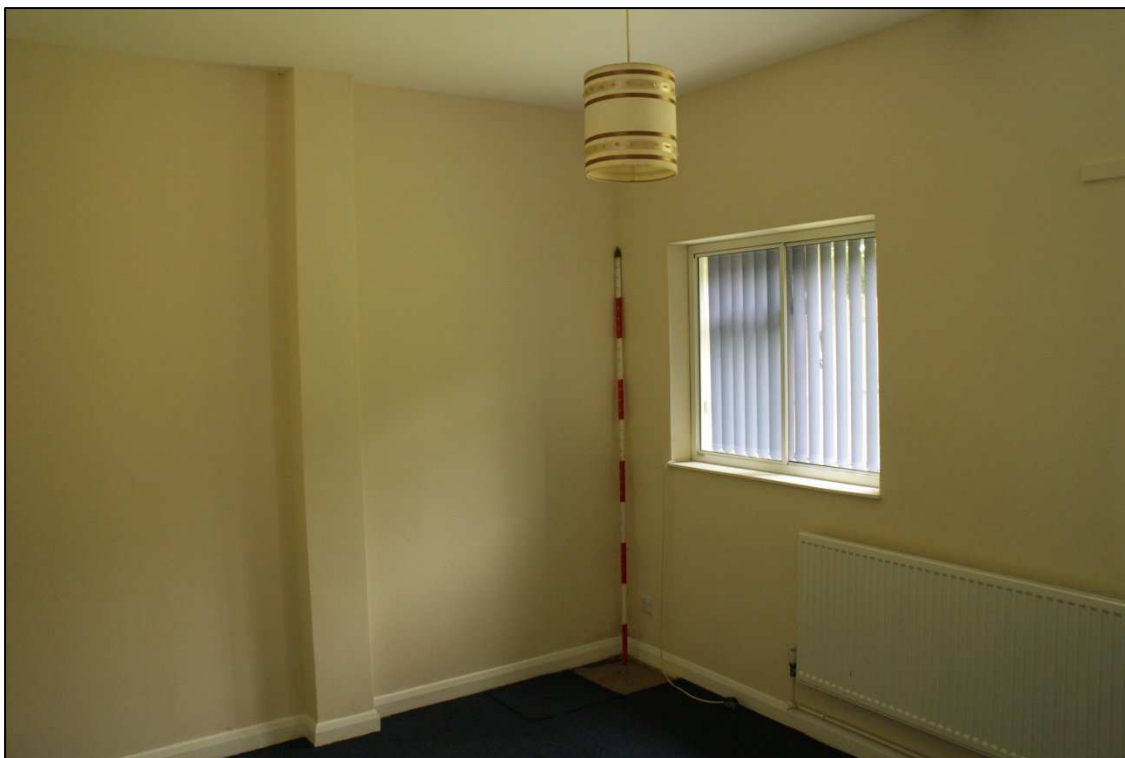
Image 13: Interior, Room G4

Looking towards north-western corner with modern window and interior wall finishes

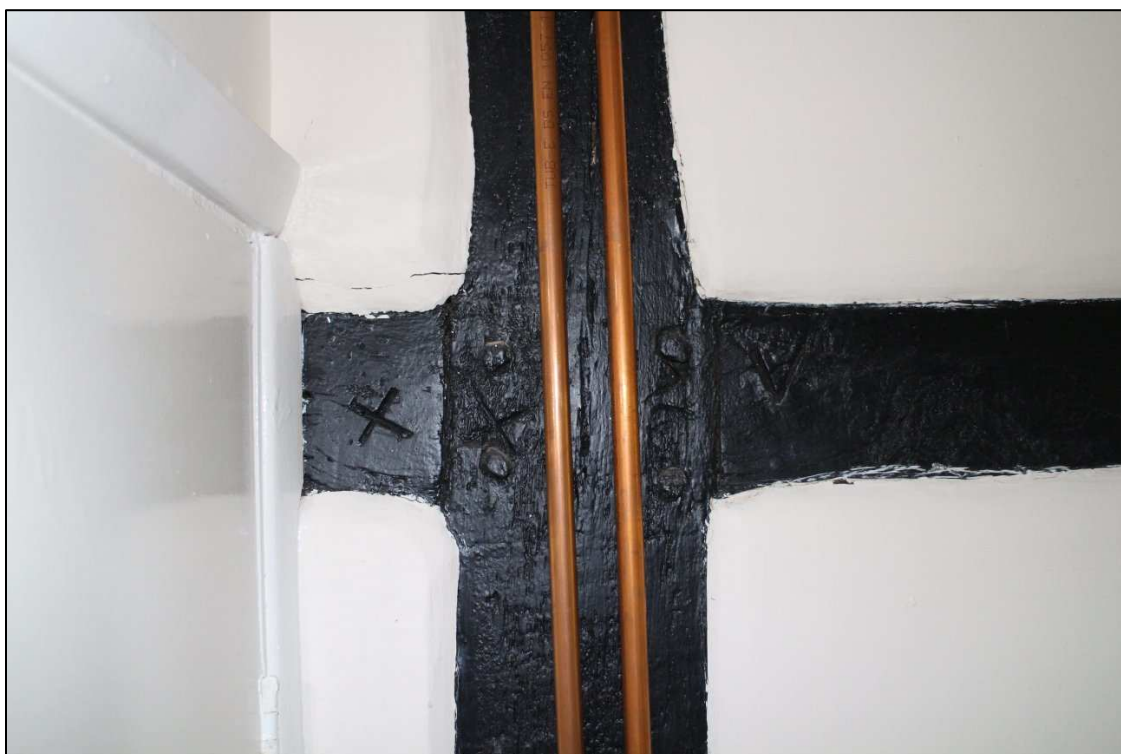
Image 16: Interior, Room G7

Showing assembly marks in timber frame

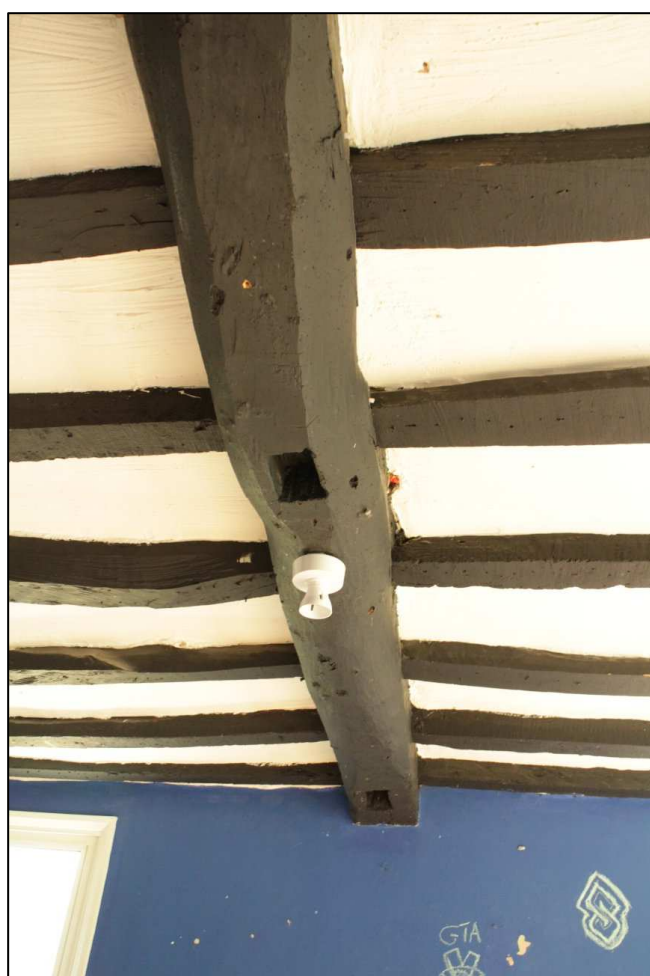
Image 18: Interior, Room F1

Looking northwards showing spine beam with empty mortise holes and joists

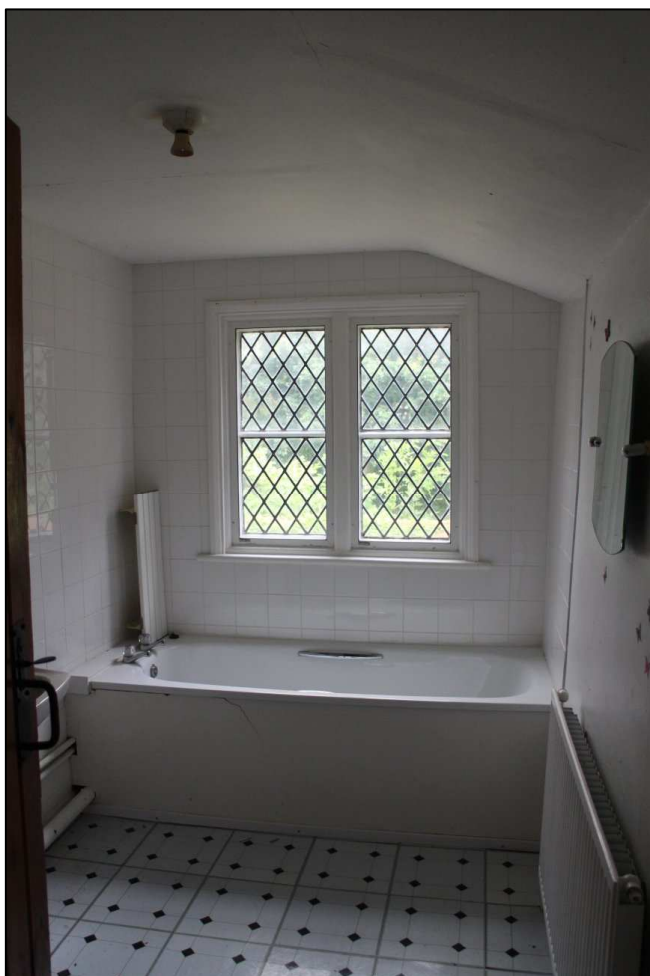
Image 21: Interior, Room F3

Looking towards north showing modern casement window with leaded lights

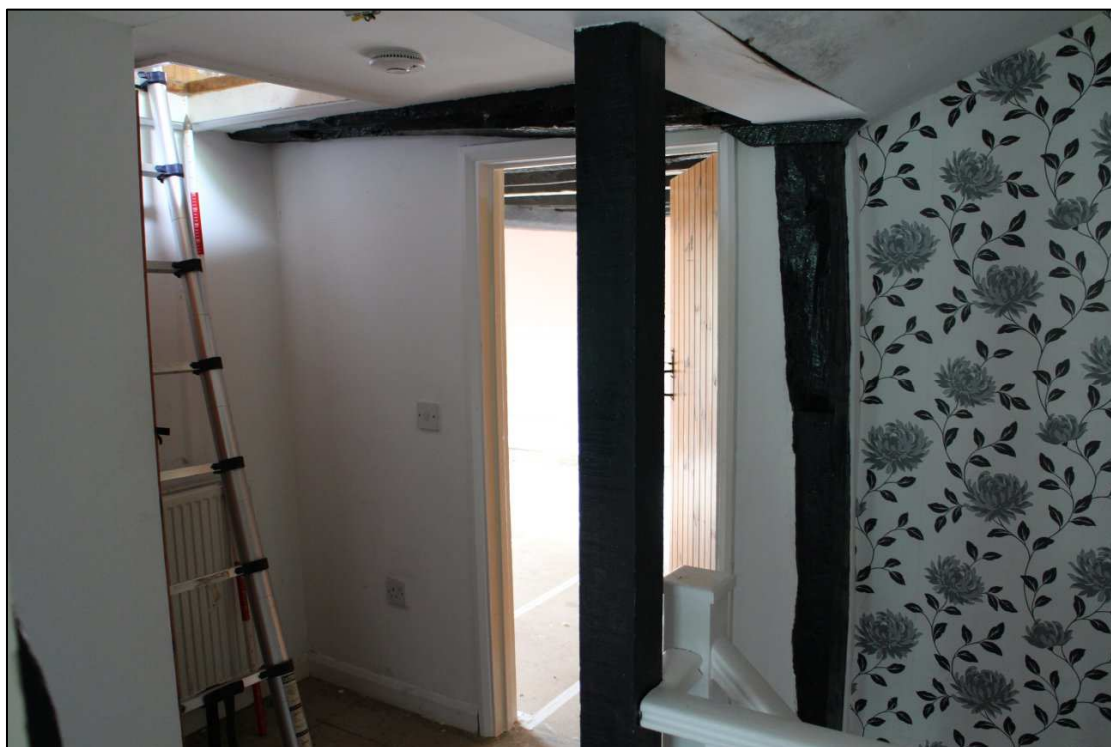
Image 22: Interior, first-floor landing

Looking towards door to Room F2, modern timber post in foreground, post at rear right is on line of rear wall of primary range with part of tiebeam visible in the ceiling

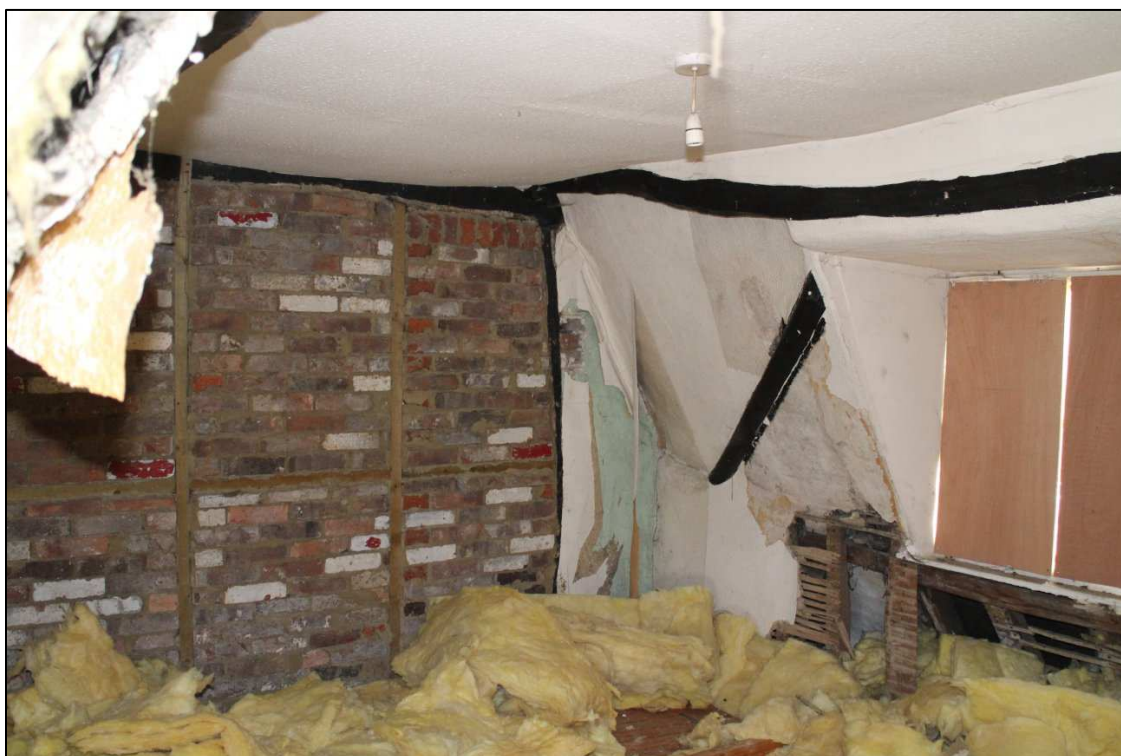
Image 23: Interior, Room A1

Looking towards the north-east showing part of end wall at left and dormer window in front elevation at right with brace truncated by dormer opening

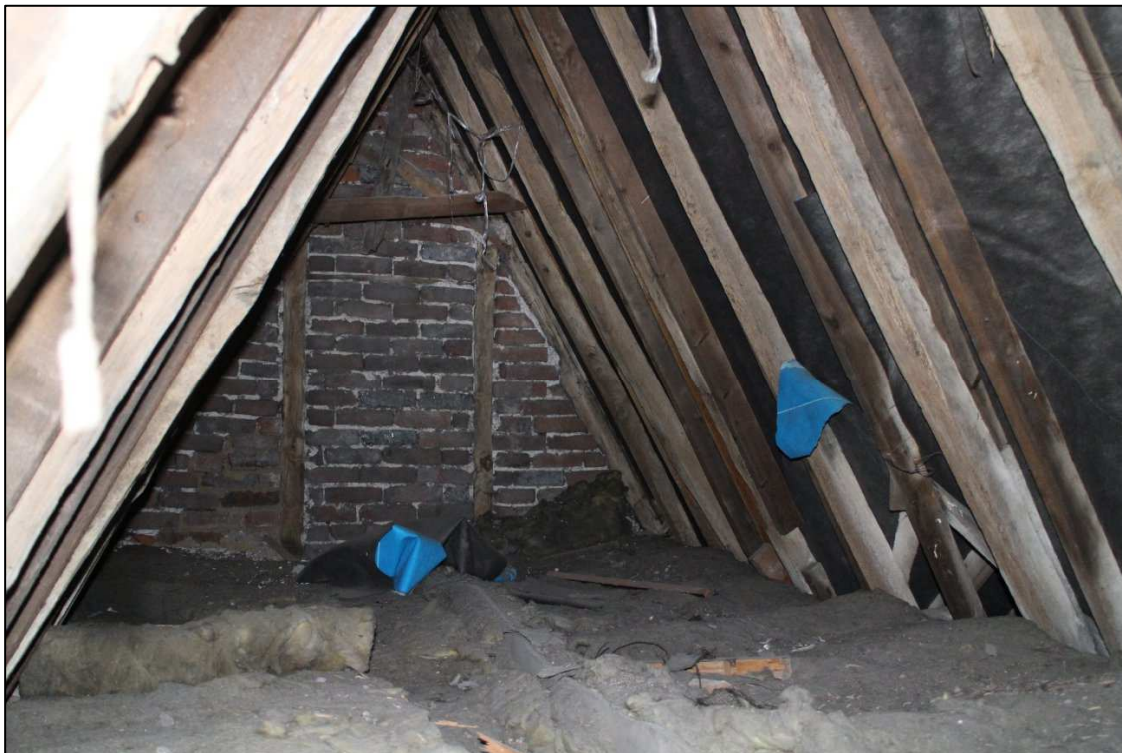
Image 25: Interior, roof space over primary range

The roof space above the attic rooms is partly visible through a ceiling hatch (Image 25). Modern repairs are evident with the common joists backed up with modern timbers. No diagnostic construction details of the roof were visible, but details visible in the exterior north-west elevation indicate that it is of clasped purlin construction.

Looking towards northern gable end
