## DESIGN & ACCESS STATEMENT (VERSION 2)

- 1.1 The Red House is located at the north west corner of the historic village of Dunstable adjacent to The Green, Houghton Regis, Dunstable, LU5 5DY.

- 1.2 The Red House is a two and a half storey Grade II listed detached property dating from the 17<sup>th</sup> Century.
- 1.3 The property has a pitched and tiled roof and central chimney stack.

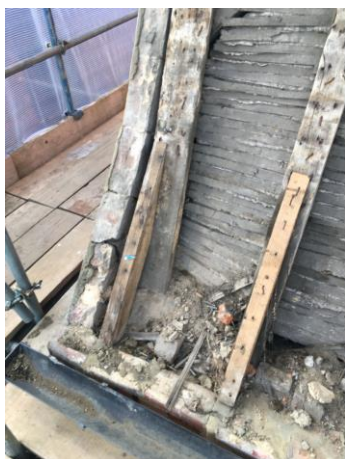
5.3.2 The pitch and profile of the existing roof structures and dormer windows, etc are to be directly replicated; including the installation of timber sprocket joists, in order to mirror the profile of the existing sprocket joists that extend the plain tiles over the wall plates and in to the gutters (as highlighted within the following photograph and Glasspool & Thaiss Consulting Structural Engineers drawing extract 18080-D21 Rev B):

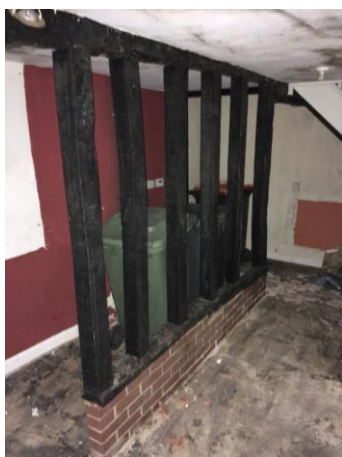
- 5.10.9 Taking down and removing the non-historic open timber stud wall / partition to the ground floor rear right hand side room G3 (as highlighted within the following photograph) and installing 2no. 150mm x 90mm PFC support beams (including PS2 550mm x 100mm x 275mm PS2 concrete padstones) to strengthen / support the existing first floor wall and roof structure; with the beams to be supported by new 2no. 200mm x 200mm SHS posts supported by new 1.2m x 1.2m x 0.6m deep GEN20 concrete pad foundations (as highlighted within the following photograph and Glasspool & Thais Consulting Structural Engineers drawing extract 18080-B04 Rev C):

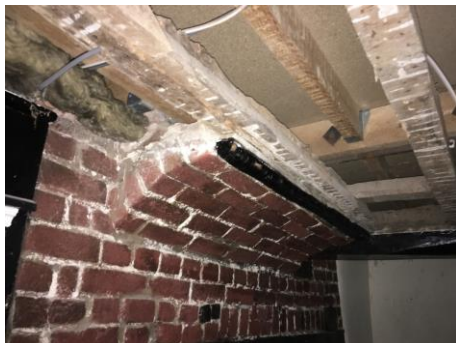
- 5.10.10 Installing a 150mm x 90mm PFC and 8mm thick web plate 400mm long welded to PFC web and 8mm thick end plate coach bolted to the face of the beam (channel to be hidden above ceiling finishes and within depth of existing floor joists), in order to support the existing brick arch detail above the fire place to the ground floor front right hand side room G1 (as highlighted within the following photograph and Glasspool & Thaiss Consulting Structural Engineers drawing extract 18080-B15 Rev C):
